STAR OF INDIA  
Report on Restoration

Star of India  
Report on Restoration  
11/20/1964  
Karl Kortum

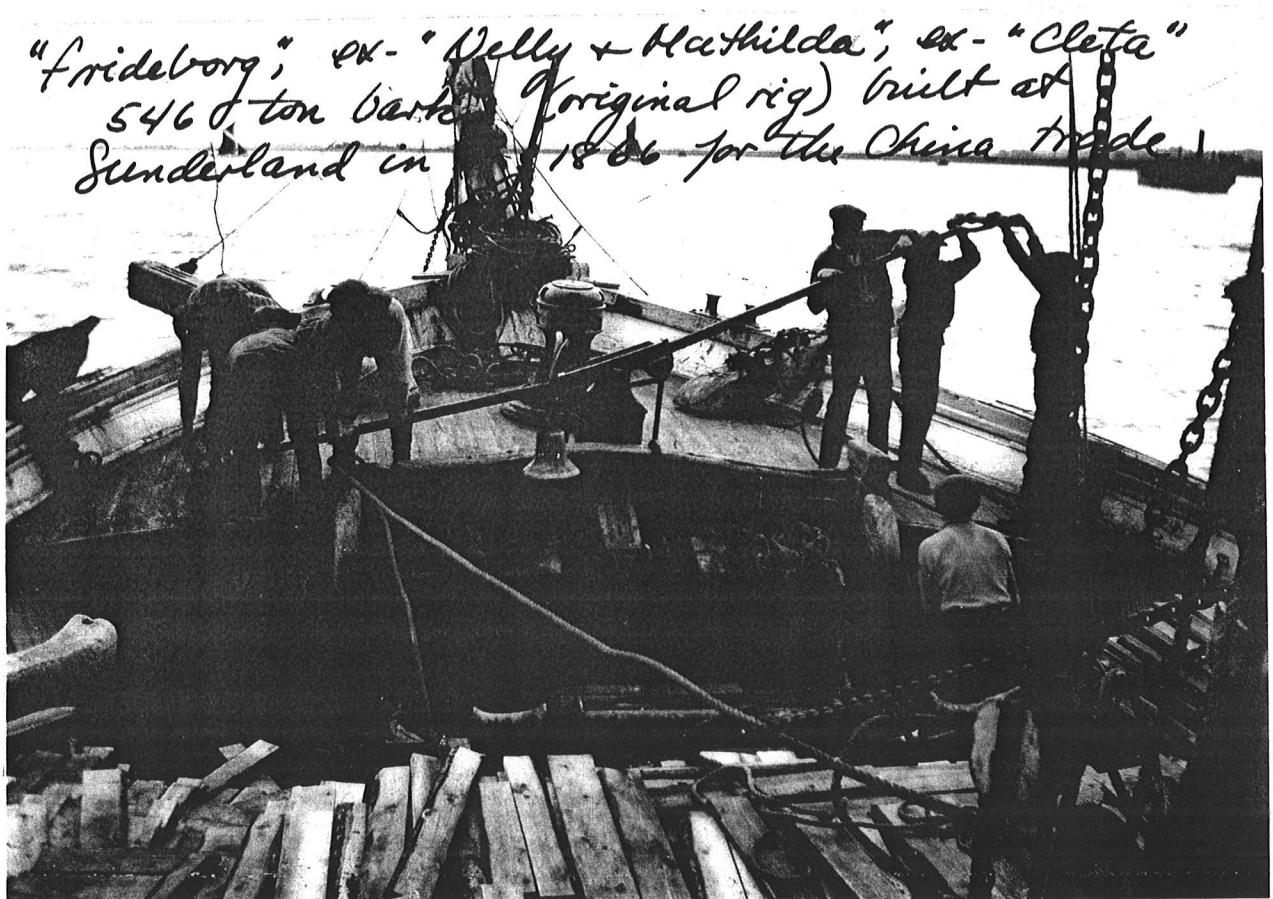
If further research substantiates the theory that the bitt formed of iron plate extending through the after end of the fo'c'sle head supported the cross head for the pump brake windlass (and in between decks formed a pawl bitt supporting the log windlass pawls) then an attempt should be made to secure such crosshead. (See photograph).
